**Flood Control Project Maintenance  
Levee Inspections**  
**LMA District Cover Sheet**  
**Spring 2013 Levee Inspection Results**

**Reclamation District No. 2058 Pescadero**

Waterway			Bank	Unit Miles
Unit No. 01 Paradise Cut			Left	6.71
	Spring (March - May)	Summer (June - August)	(September - November) Fall	Winter (December - February)
Unit Maintenance Rating (Fall Only)				
Date of Inspection	05/22/2013 - 05/22/2013			
DWR Inspector	Maksim Khashchuk			
Accompanied By	Greg Pombo

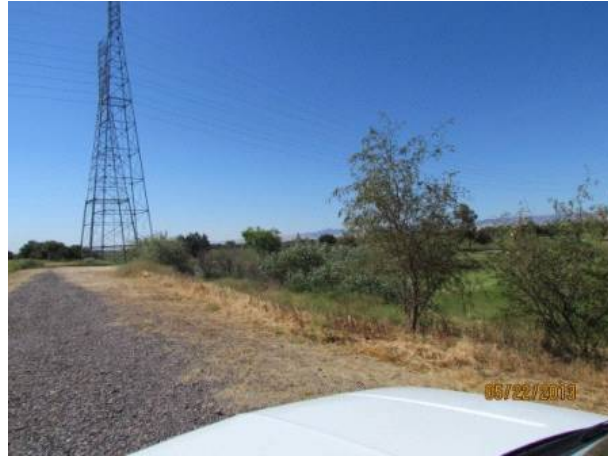
Levee Mile Report Line	4
Start Levee Mile	0.41
End Levee Mile	0.44
Location	Land Side
Category	
Item	Vegetation

View of the vegetation on the landside levee slope.

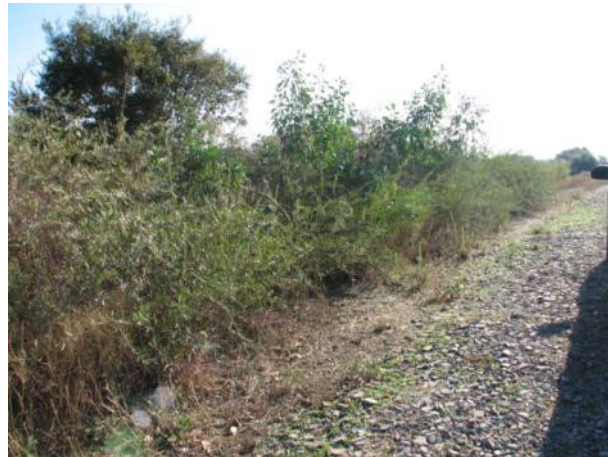
Levee Mile Report Line	5
Start Levee Mile	0.42
End Levee Mile	0.42
Location	Water Side
Category	
Item	Vegetation

11/08/2011 Thick brush in this area needs to be taken back to 20' from hinge point.

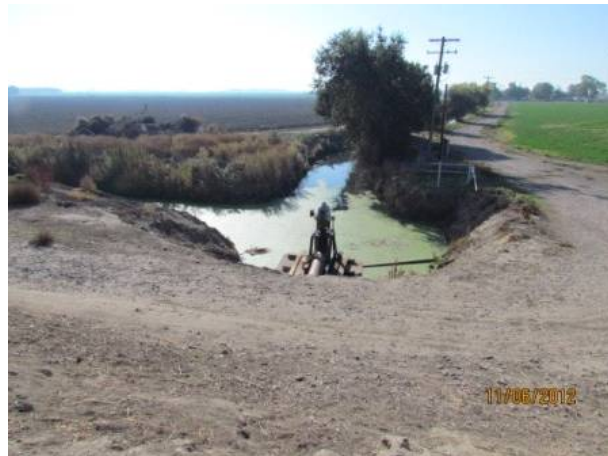
Levee Mile Report Line	6
Start Levee Mile	0.73
End Levee Mile	0.73
Location	Land Side
Category	
Item	Encroachments

View of discharge pipe on landside slope.

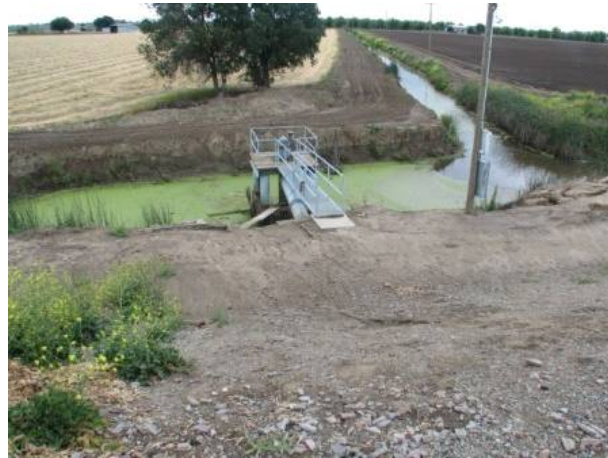
Levee Mile Report Line	9
Start Levee Mile	1.24
End Levee Mile	1.24
Location	Crown
Category	
Item	Encroachments

Drainage discharge to Paradise Cut.

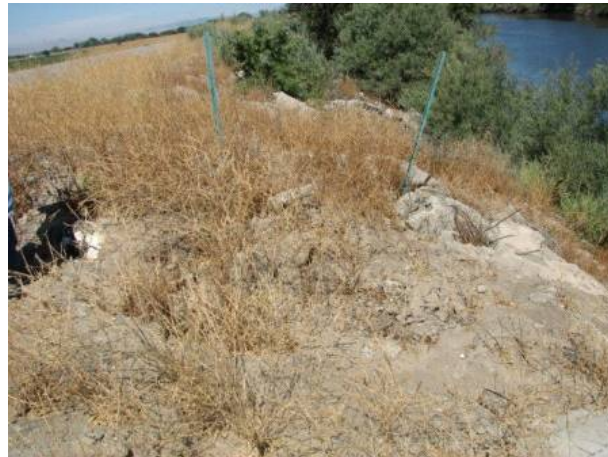
Levee Mile Report Line	11
Start Levee Mile	2.15
End Levee Mile	2.15
Location	Water Side
Category	Supplemental
Item	DWR Erosion Survey

LMR No.	Levee Mile		Category	Item	Location	Rating	Action/Comment	GPS Latitude/Longitude		Issue No.
	Start	End						Start	End	
11	2.15	2.15	Supplemental	DWR Erosion Survey	WS	M	Inspector Comments: 07/31/2012: Site was visited on 07/26/2012. No significant change observed. A new vertical pipe was installed and concrete blocks left on the site. Dense vegetation around the site. No signs of new leaks or spill from the siphon breaker. 09/02/2011: Site was not visited due to the time limit. 09/22/2010: No significant changes observed. Vegetation downstream, upstream and on the lower slope of the site have been recently sprayed. These areas were also fenced off during the site visit, making it difficult for us to examine the condition of the lower slope. Possible leak or spill from the siphon breaker is creating notches along the slope and developing into a headward erosion. If the problem continues, it will erode the slope and fully expose the pipe to outside elements. 07/23/2009: A possible leak or spill from a siphon breaker is eroding the slope and developing into a headward erosion; a portion of the buried pipe is exposed; the lower slope seems to be lined with chunks of concrete debris or other rock material. [2012 Site ID:RD2058U01RM1.78]	37.803769 ° -121.386341 °	37.803769 ° -121.386341 °	1 Y

Close look at the site. Note the concrete blocks and vegetation.

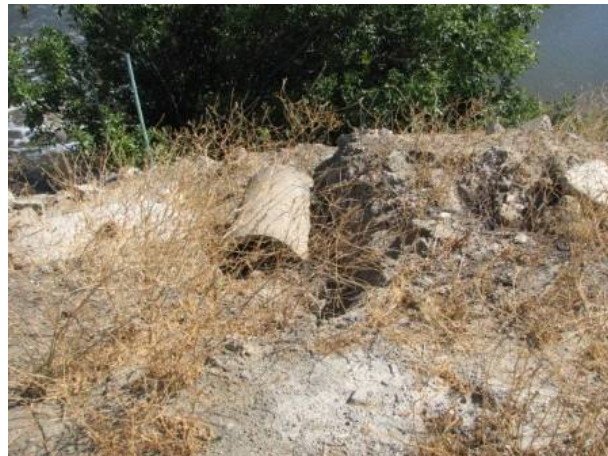
Levee Mile Report Line	11
Start Levee Mile	2.15
End Levee Mile	2.15
Location	Water Side
Category	Supplemental
Item	DWR Erosion Survey

Direct view of siphon breaker.

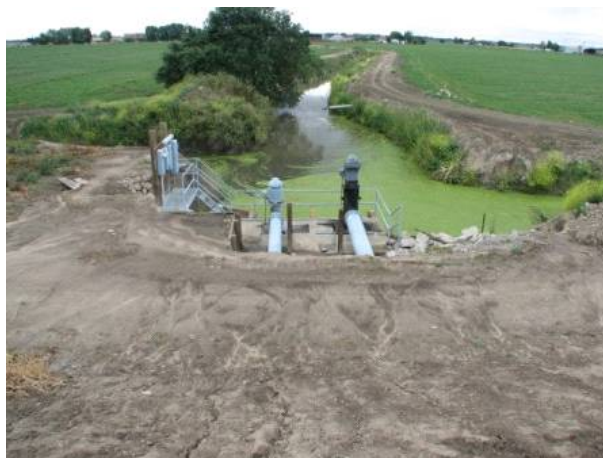
Levee Mile Report Line	12
Start Levee Mile	2.15
End Levee Mile	2.15
Location	Crown
Category	
Item	Encroachments

Drainage discharge to Paradise Cut.

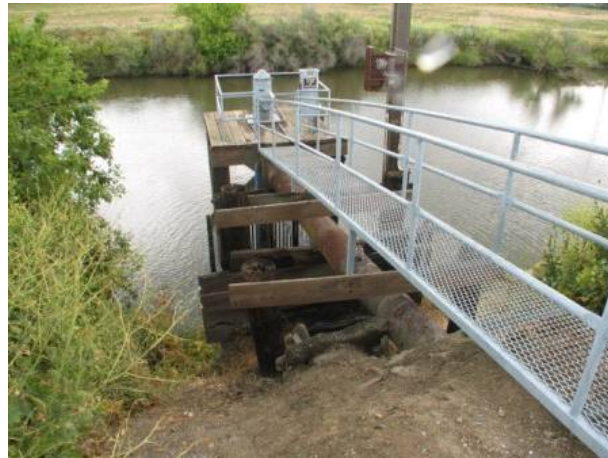
Levee Mile Report Line	18
Start Levee Mile	2.89
End Levee Mile	2.89
Location	Water Side
Category	
Item	Encroachments

Irrigation intake from Paradise Cut.

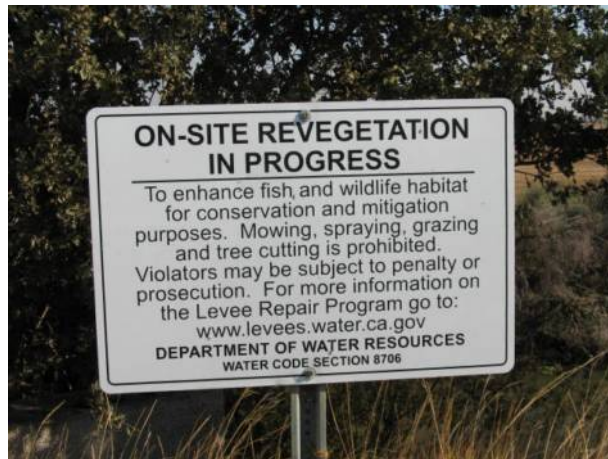
Levee Mile Report Line	22
Start Levee Mile	3.85
End Levee Mile	3.85
Location	Water Side
Category	
Item	Vegetation

11/08/2011 Revegetation site, cannot trim or cut vegetation in this area.

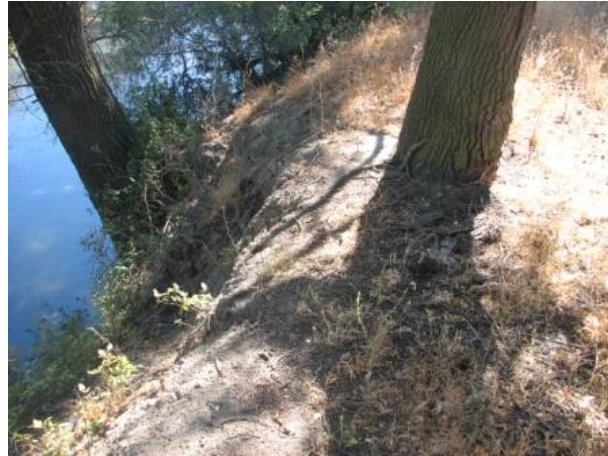
Levee Mile Report Line	26
Start Levee Mile	4.49
End Levee Mile	4.53
Location	Water Side
Category	Supplemental
Item	DWR Erosion Survey

DWR ID: DWR_RD2058_01_s_2012_69									
25	4.36	4.36		Vegetation	WSA/W Ma	V4 : Elderberries are blocking visibility and flood fight capability.	37.789794 ° -121.354883 °	37.789794 ° -121.354883 °	71
DWR ID: DWR_RD2058_01_s_2012_71									
26	4.49	4.53	Supplemental	DWR Erosion Survey	WS Ma	Inspector Comments: 07/26/2012: The site has been visited, and no significant change has been observed. 09/02/2011: This site was not visited due to the time limit. 09/22/2010: No significant changes observed. Minor pocket erosions are lined at the lower bank. Two large Oak and Willow trees are on midslope and bench. The remaining bench was re-measured and found to be approximately 10 feet. There was no indication of active erosion on site during the site visit. 08/05/2010: Recommended for annual assessment and monitoring of site during flood events, per CLRO. 07/23/2009: No major change observed since last visit; site is a 200-ft. long near-vertical berm erosion; recommend annual assessment and monitoring of erosion site, per CLRO CES Evaluation 2008 Report; Site # is the same site previously reported as RM4.0,LM4.51; previously rated "U". 09/10/2008: Two large trees (2-3' DBH) with partial roots exposed. 2007: Visited site 03/13/2007. [2012 Site ID:RD2058U01RM3.97]	37.789810 ° -121.352490 °	37.789810 ° -121.352490 °	2 Y

Direct view at a pocket erosion site. Vegetation has developed and covered the erosion.

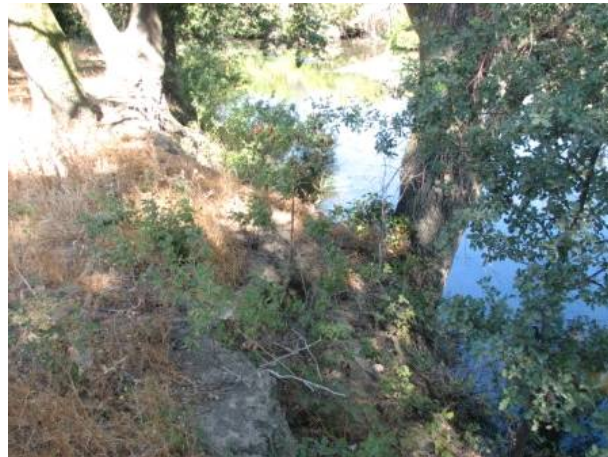
Levee Mile Report Line	26
Start Levee Mile	4.49
End Levee Mile	4.53
Location	Water Side
Category	Supplemental
Item	DWR Erosion Survey

Direct view at a the erosion near a tree

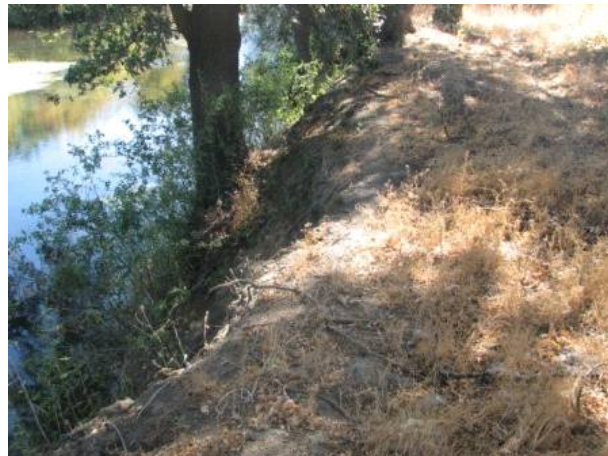
Levee Mile Report Line	26
Start Levee Mile	4.49
End Levee Mile	4.53
Location	Water Side
Category	Supplemental
Item	DWR Erosion Survey

Direct view at a the erosion near a tree

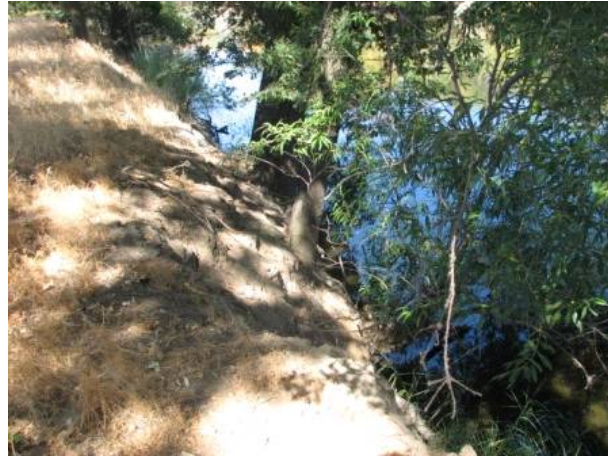
Levee Mile Report Line	26
Start Levee Mile	4.49
End Levee Mile	4.53
Location	Water Side
Category	Supplemental
Item	DWR Erosion Survey

Direct view at a the erosion near a tree

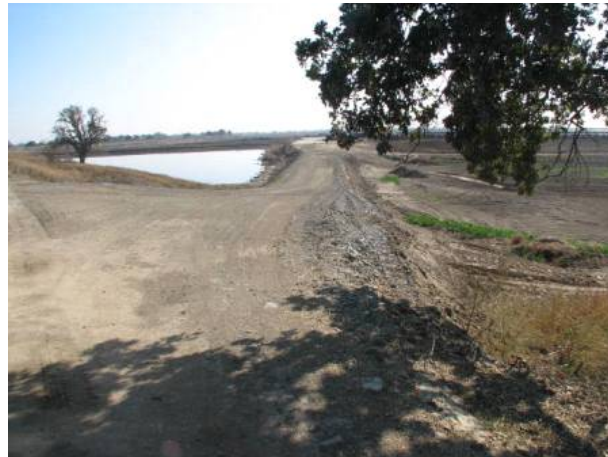
Levee Mile Report Line	27
Start Levee Mile	5.16
End Levee Mile	5.16
Location	Land Side
Category	
Item	Encroachments

DWR ID: DWR_RD2058_01_s_2013_2									
27	5.16	5.16		Encroachments	LS En	RA : Ramp Inspector Comments: New Ramp construction Connecting Dairy to levee. Construction of ramp results in a new pond on the landside of the levee. 2/21/2012, owner has said that he will contact the CVFPB to resolve this issue.	37.783102 ° -121.345682 °	37.783102 ° -121.345682 °	29 Y
DWR ID: DWR_RD2058_01_s_2012_29									
28	5.37	5.37		Encroachments	LS En	RA : Ramp Inspector Comments: Ramp constructed to dairy. Raised ramps, see issue 29 are creating new holding ponds for dairy at levee toe.	37.782268 ° -121.342257 °	37.782268 ° -121.342257 °	30 Y
DWR ID: DWR_RD2058_01_s_2012_30

11/08/2011 New ramp has been constructed by Dairy farmer connecting his barns to the levee.

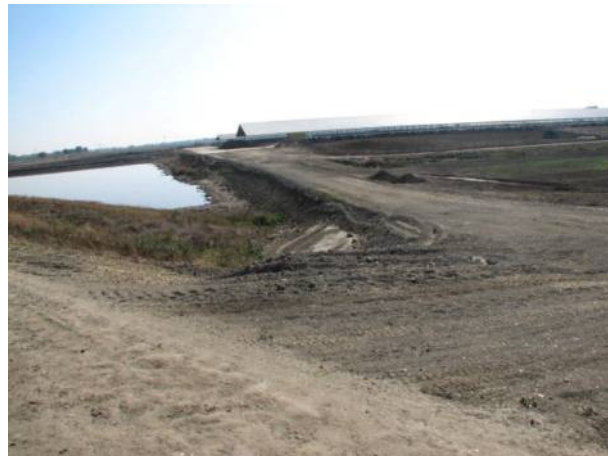
Levee Mile Report Line	27
Start Levee Mile	5.16
End Levee Mile	5.16
Location	Land Side
Category	
Item	Encroachments

11/08/2011 New ramp has been constructed by Dairy farmer connecting his barns to the levee.

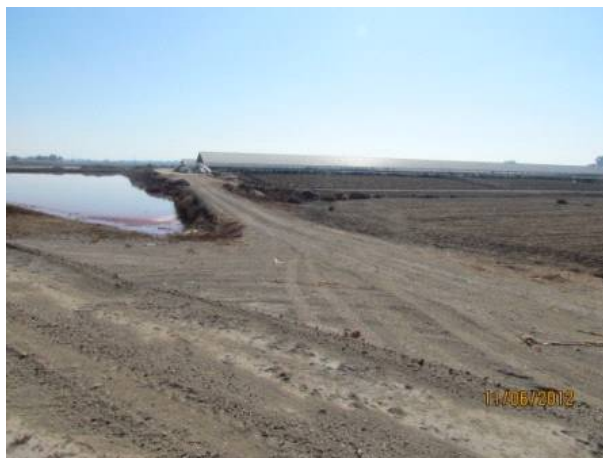
Levee Mile Report Line	27
Start Levee Mile	5.16
End Levee Mile	5.16
Location	Land Side
Category	
Item	Encroachments

Completed new ramp constructed by Dairy farmer connecting his barns to the levee.

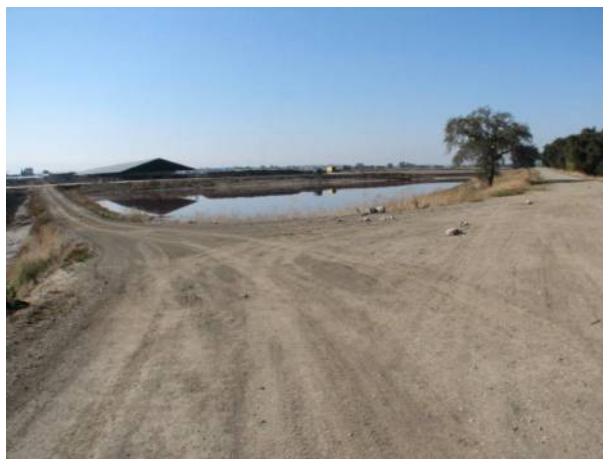
Levee Mile Report Line	28
Start Levee Mile	5.37
End Levee Mile	5.37
Location	Land Side
Category	
Item	Encroachments

11/08/2011 Photo shows existing middle ramp to the levee which has been raised.

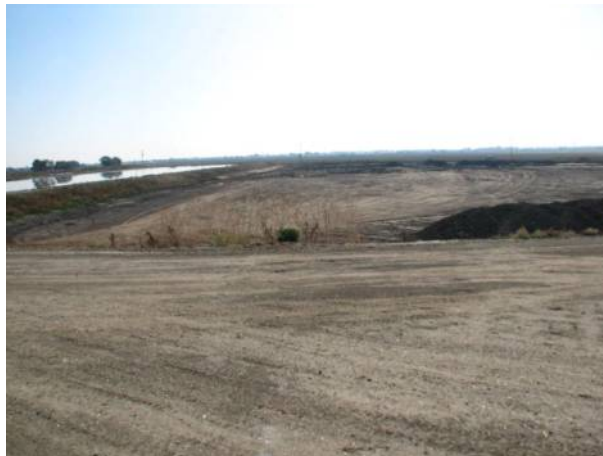
Levee Mile Report Line	28
Start Levee Mile	5.37
End Levee Mile	5.37
Location	Land Side
Category	
Item	Encroachments

11/08/2011 Photo shows view from the levee looking to the left of the middle ramp.

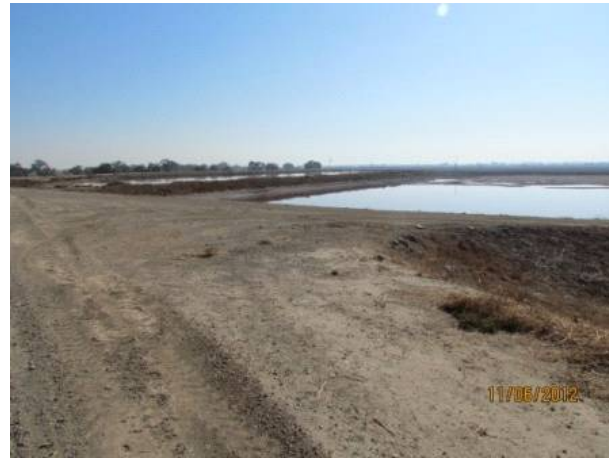
Levee Mile Report Line	28
Start Levee Mile	5.37
End Levee Mile	5.37
Location	Land Side
Category	
Item	Encroachments

Completed new ramp constructed by Dairy farmer connecting his barns to the levee.

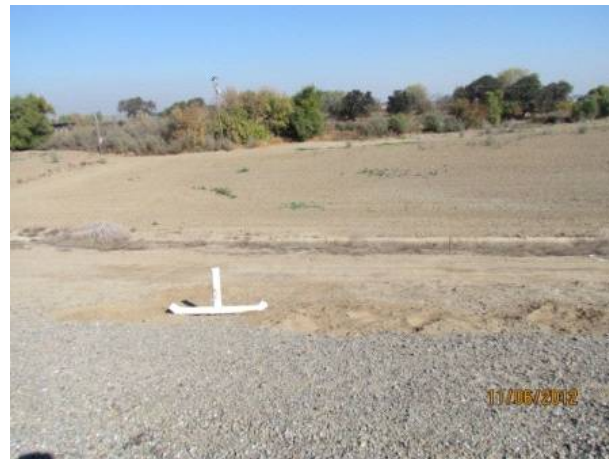
Levee Mile Report Line	29
Start Levee Mile	6.06
End Levee Mile	6.06
Location	Water Side
Category	
Item	Animal Control

LMR No.	Levee Mile		Category	Item	Location *	Rating ** +	Action/Comment	GPS Latitude/Longitude		Issue No. Photo
	Start	End						Start	End	
29	6.06	6.06		Animal Control	WS	M	A3 : No rodents visible, but rodent burrows visible; need to backfill and compact or grout burrows.	37.775015 ° -121.335233 °	37.775015 ° -121.335233 °	5 Y

View of rodent burrows on waterside slope.
